**Adhesion Failure To Upper Substrate**

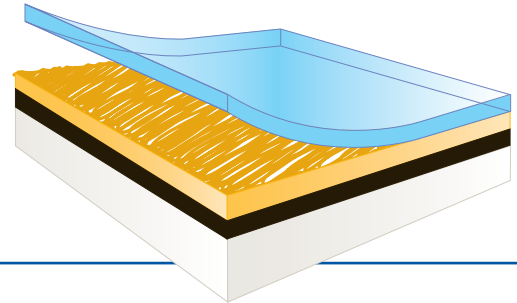
- Upper substrate comes off clean.
- All adhesive stays on the lower substrate.

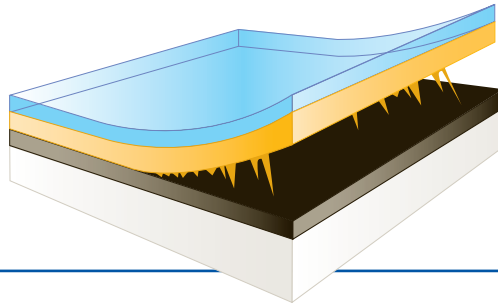
**Adhesive Failure To Ink**

- Adhesive stays with the upper substrate.
- No adhesive residue on lower substrate.

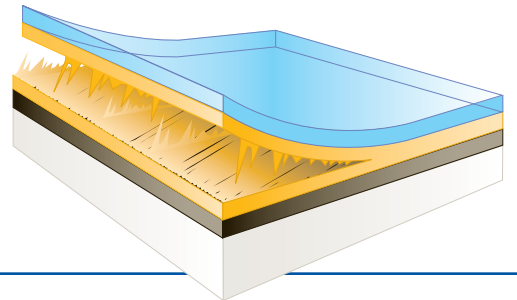
**Adhesive Shear Failure**

- Some adhesive stays with the upper substrate.
- Some adhesive stays with the lower substrate.
- Adhesive internal strength was exceeded.

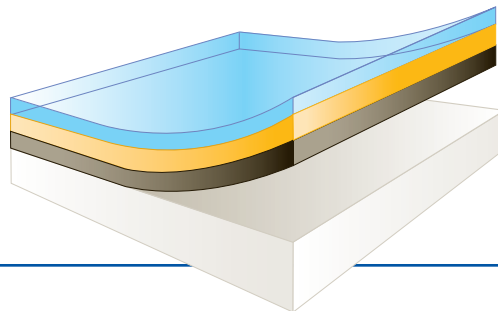
**Ink Anchorage To Core Failure**

- Adhesive and ink remains with the upper substrate.
- Adhesive was able to separate layers below it.

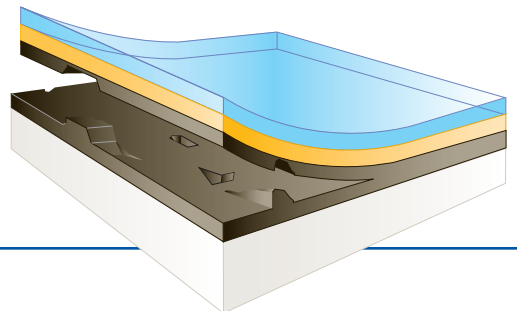
**Ink Shear Failure**

- Some ink stays with the upper substrate.
- Some ink stays with the lower substrate.
- Ink internal strength was exceeded.

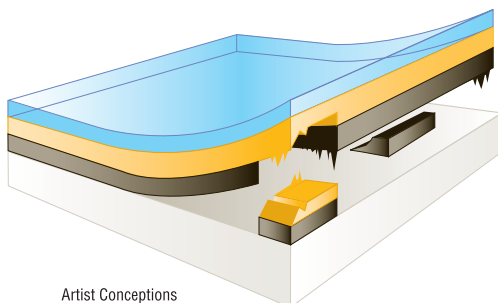
**Combination Of All Failures**

- Peel is inconsistent with high and low values.
- Records chattering and zippering effect during peel test.
- No one single interface is the weakest link.
